Meșteño Draw Restoration: Induced Meandering

Mesteño Draw was divided into three reaches. Decision was made to apply Induced Meandering to the upper reach and defer treatment on the lower two.

Induced Meandering structures to restore a slightly incised Rosgen G channel to its original Rosgen C channel type. Structures were installed during a May 2005 workshop and at later dates with individual volunteer help.

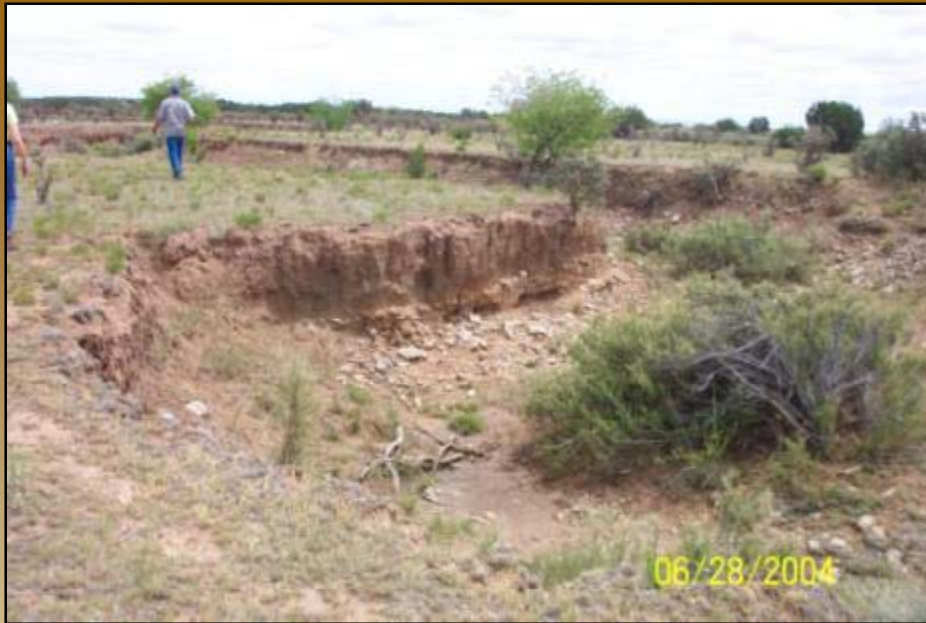
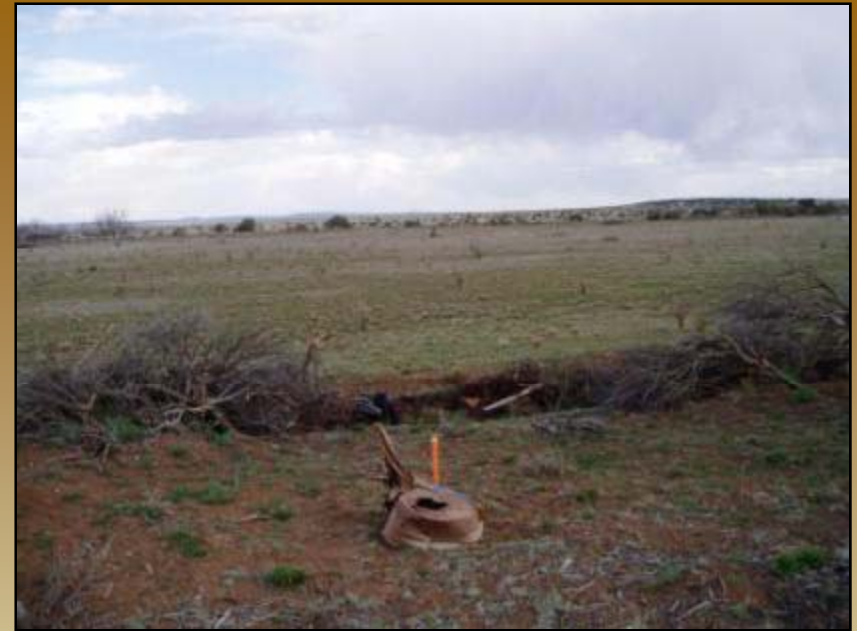
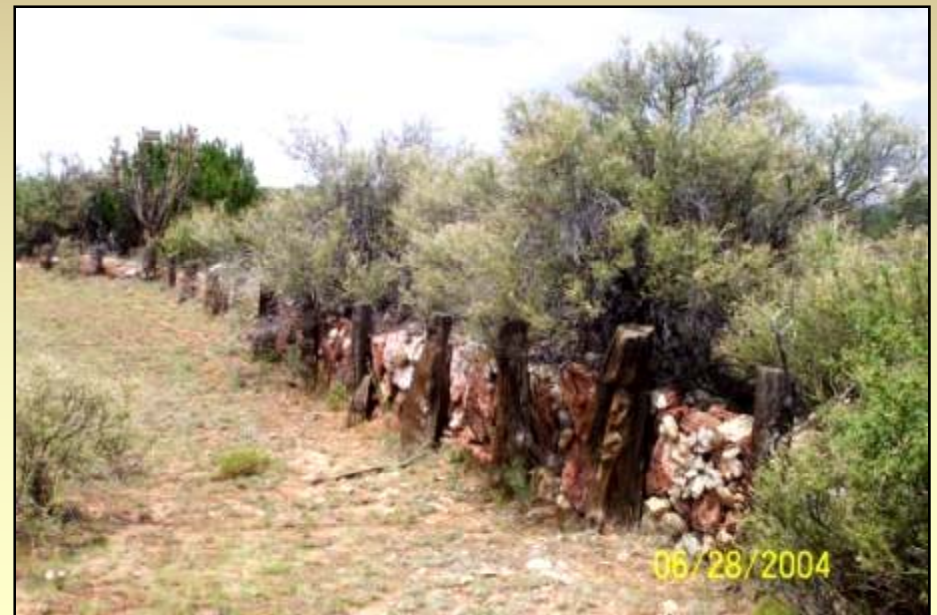
LAND IMPACTS

1. Relocation of the creek to enhance farmland irrigation and to protect corrals and barns from flooding.
2. Historic year-long grazing by domestic livestock.
3. Water diverted away from a natural slope wetland (delta fan) and used for irrigation.

Effects of past management:

1. Straightening of the creek led to down cutting of the channel bed, a drop in the water table upstream from the point of diversion, and side channel erosion.
2. Dehydrated the former slope wetland
3. Concentrated flows causing channelization downstream from point of diversion

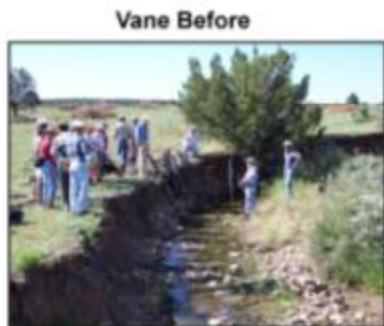
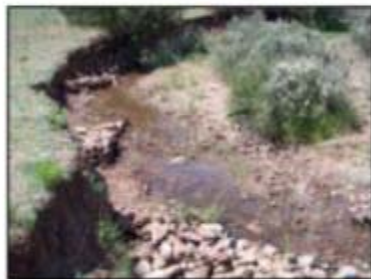
Map Location 01, 02

Vane Before

Vane After

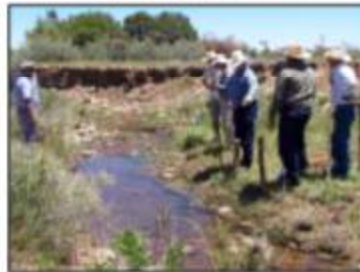
Map Location 09

Picket Baffle Before

Picket Baffle After

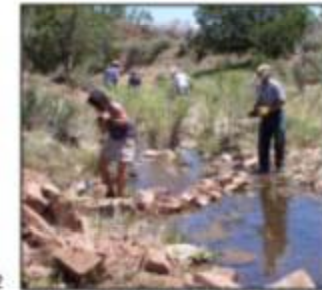
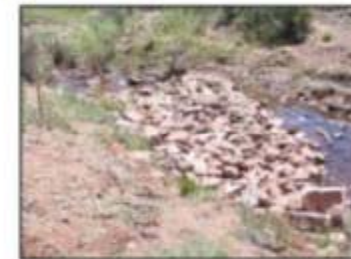
Map Location 12

Rock Baffle Before

Rock Baffle After

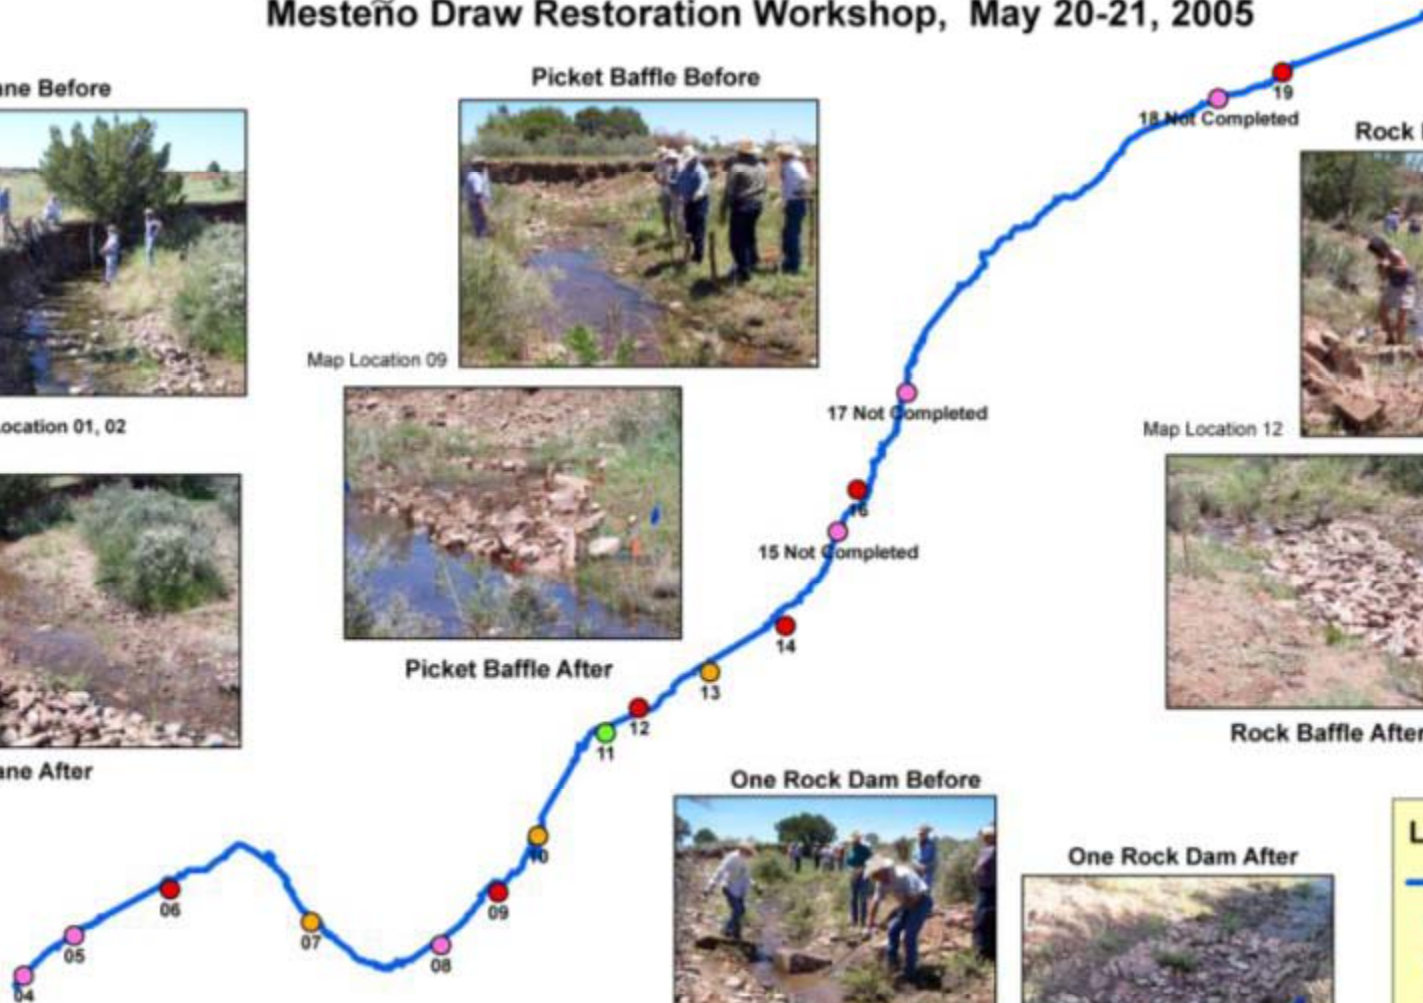
Legend

- Stream
- baffle
- onerock
- headcut ctrl
- vane
- wier

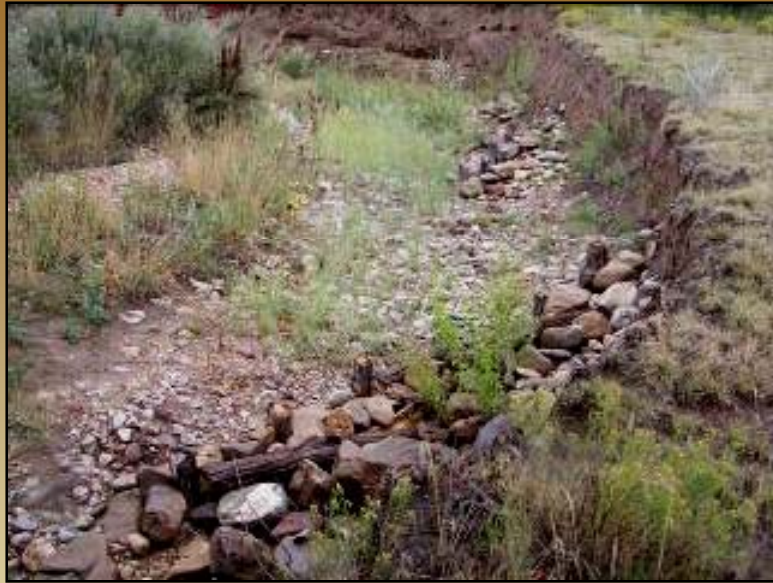
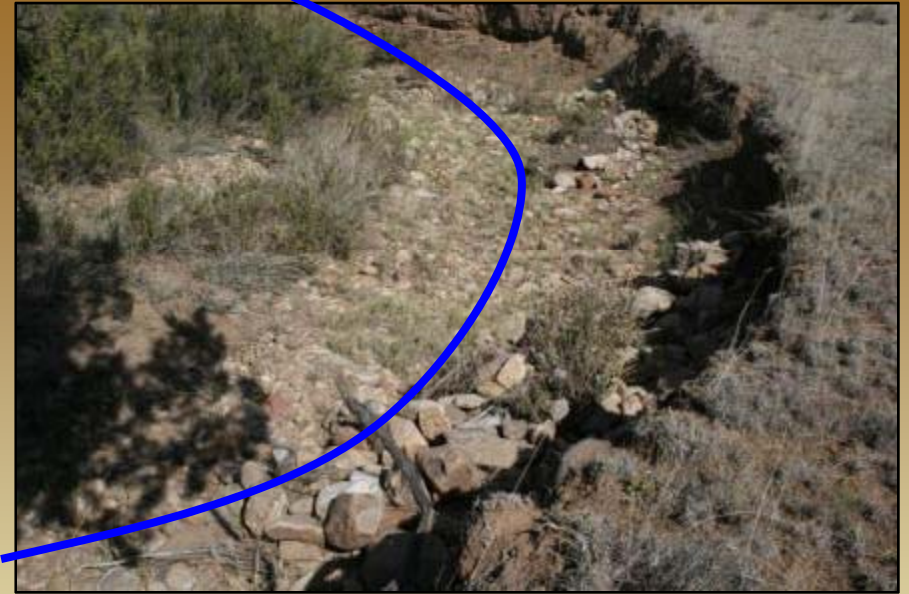
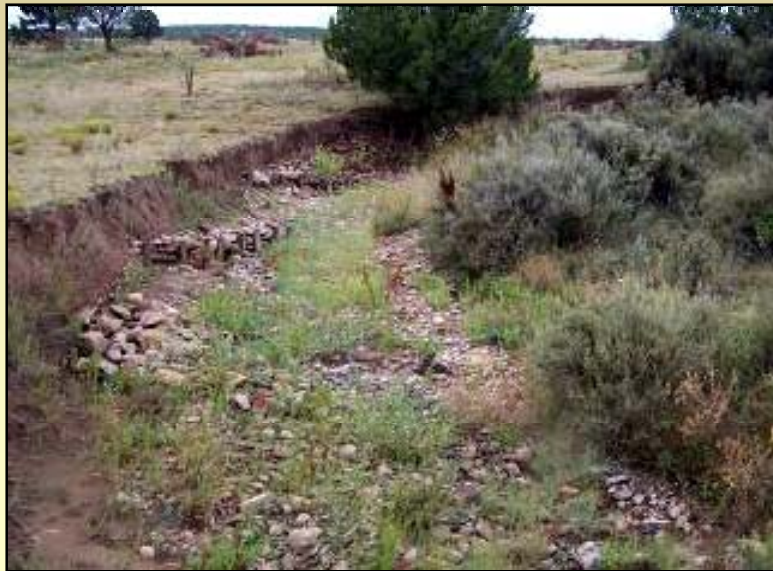
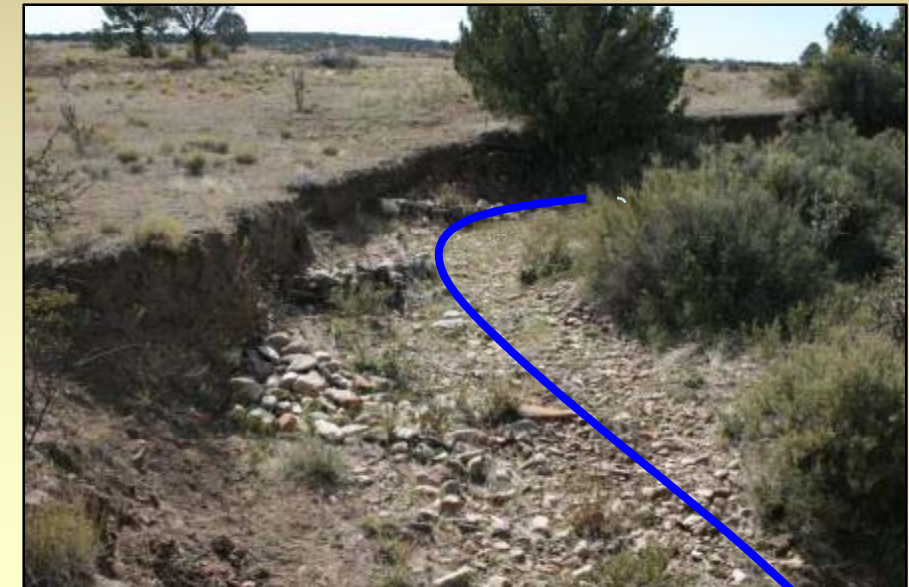
Vanes # 1 & 2 and Baffle #3

October 2005

October 2007

Downstream

Upstream

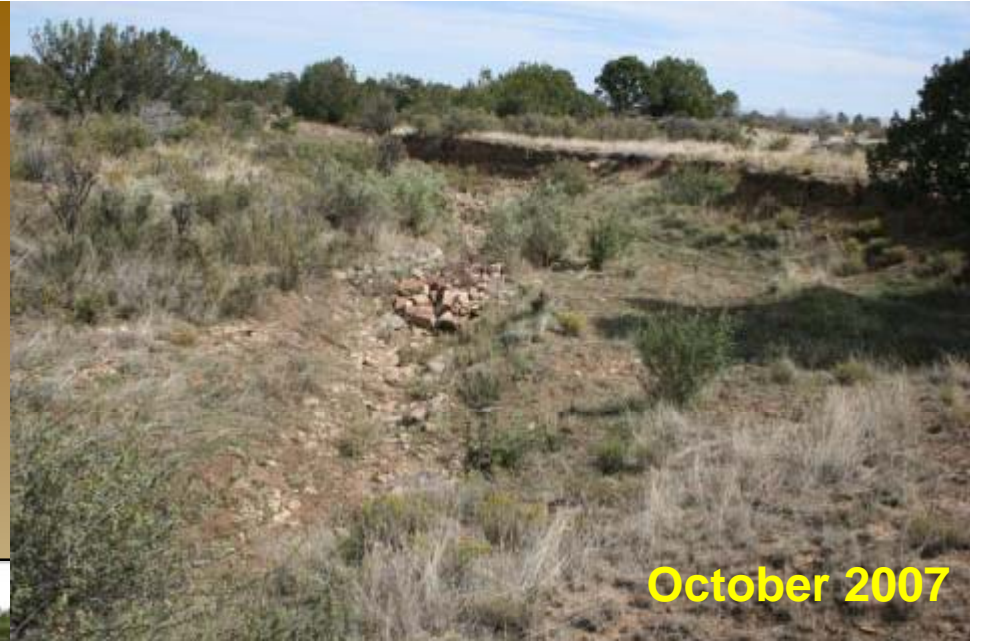
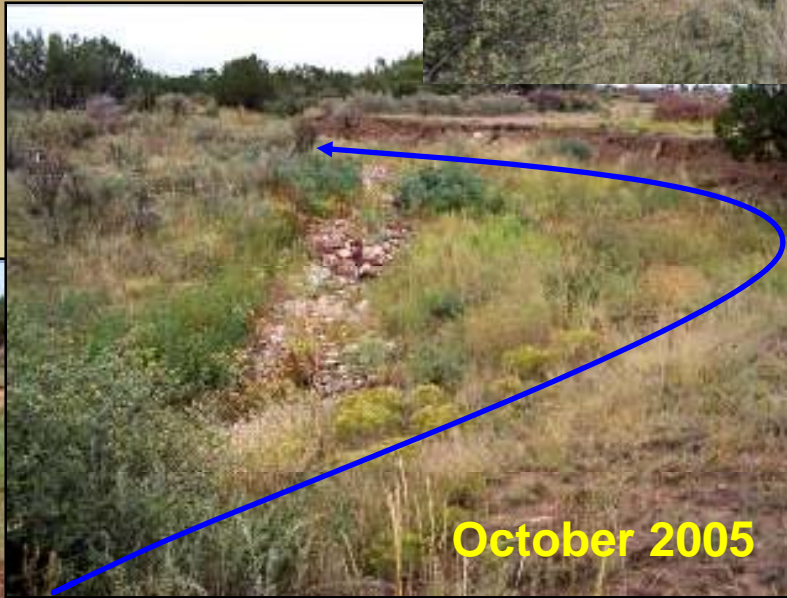
Rock Weir #8

Looking downstream

**Drought
Conditions in
2007**

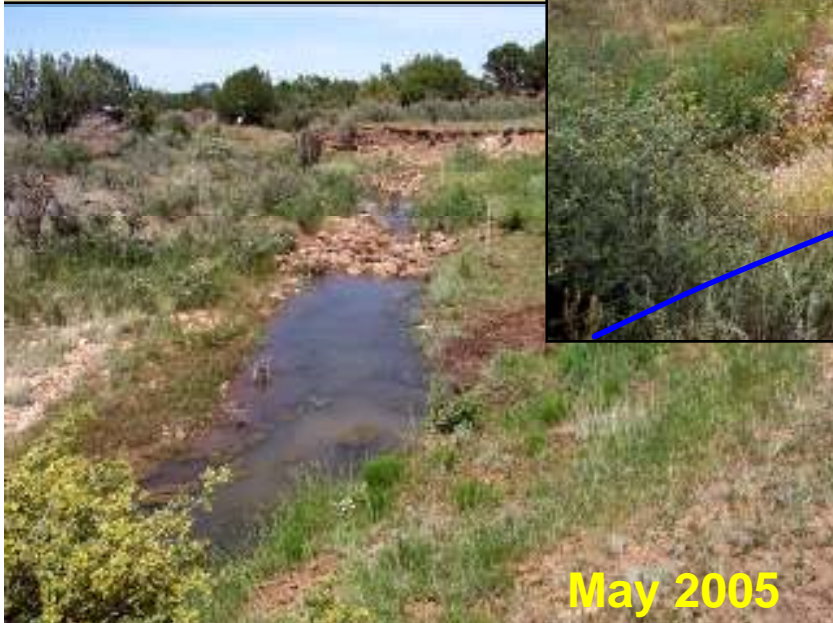
May 2005

Plugged cut-off channel to reconnect bankfull discharge with historic floodplain.

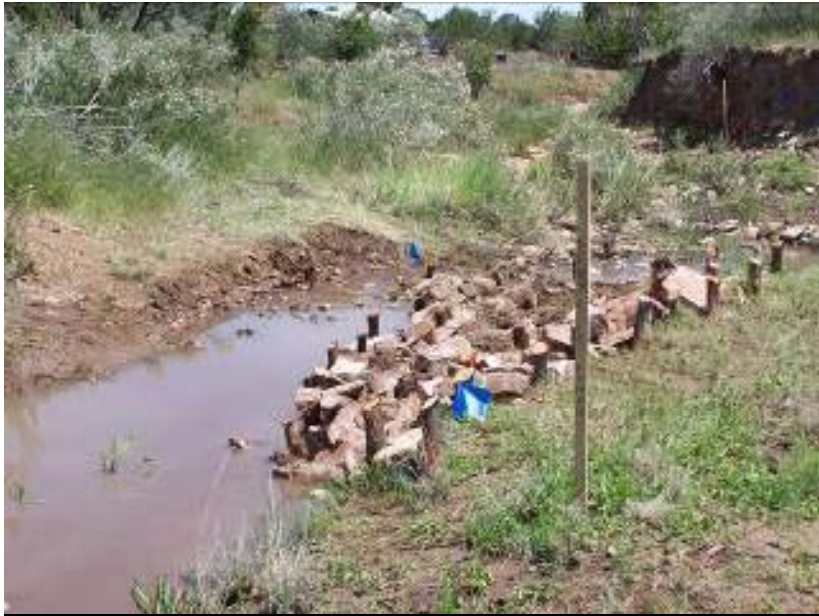
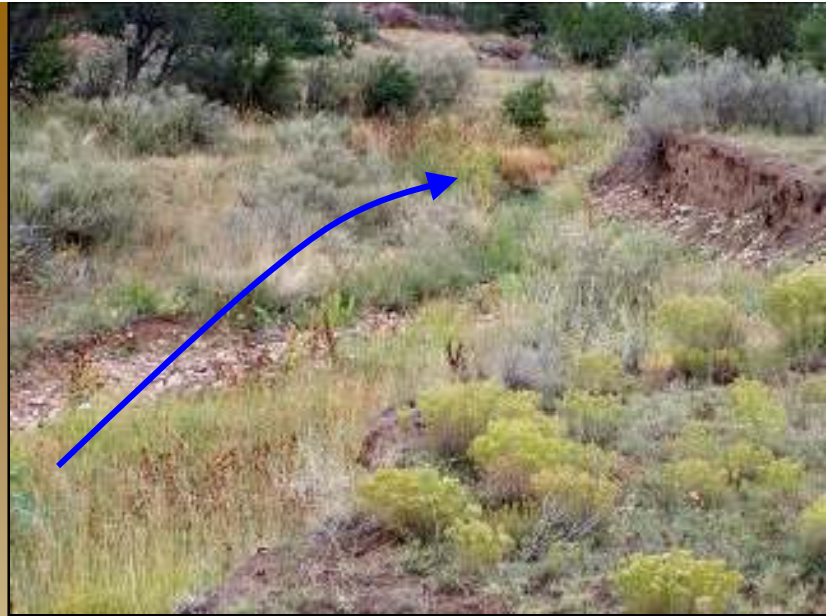
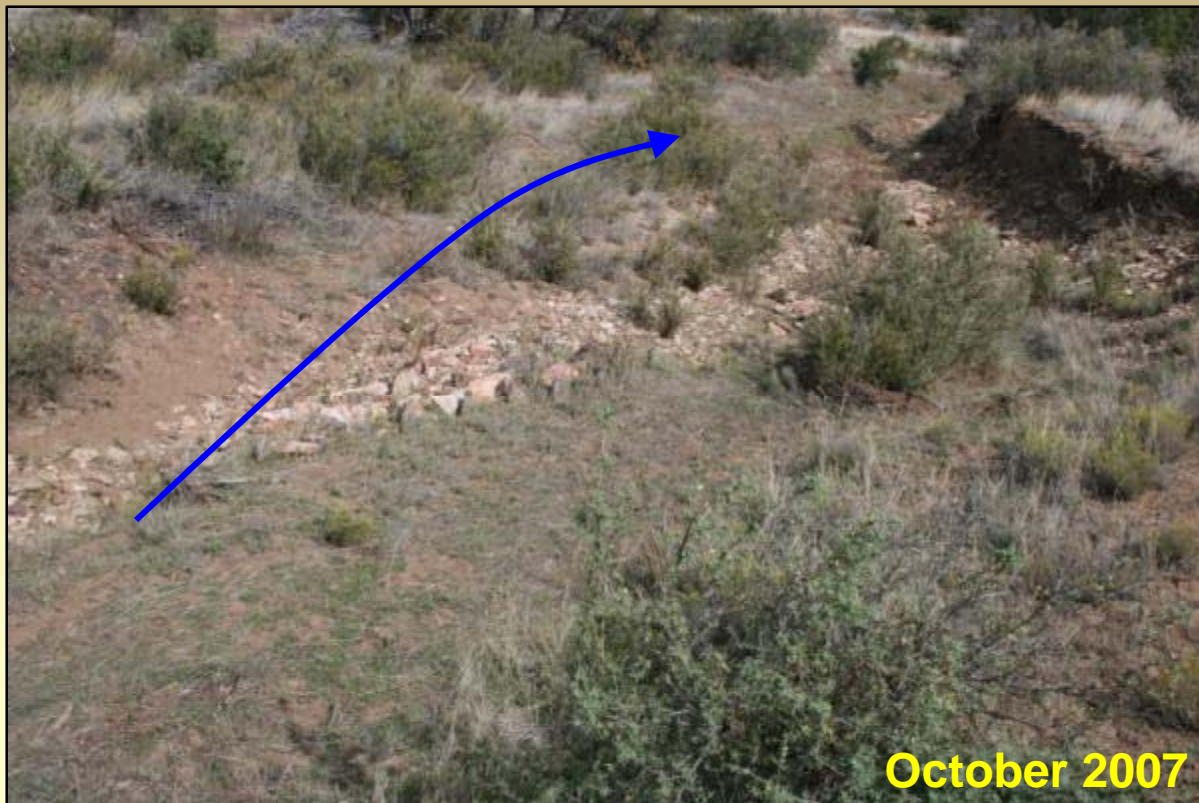
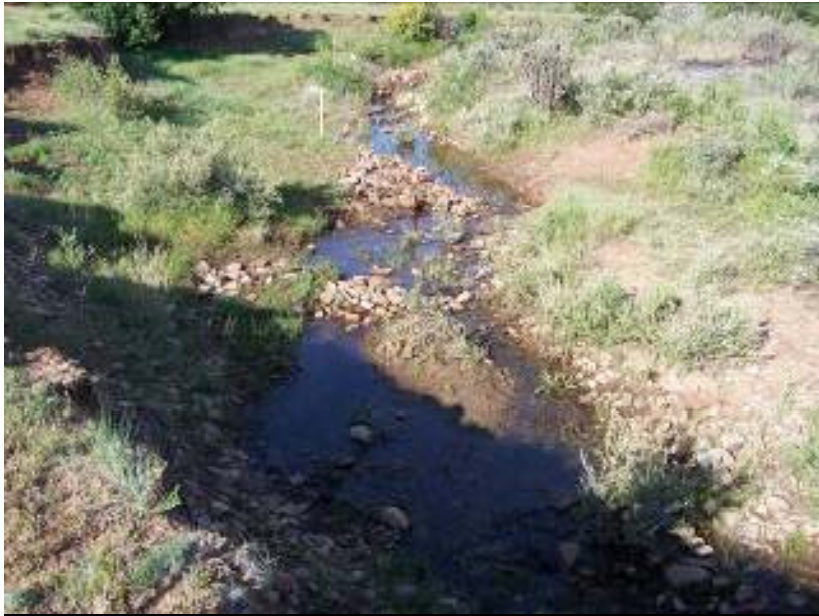
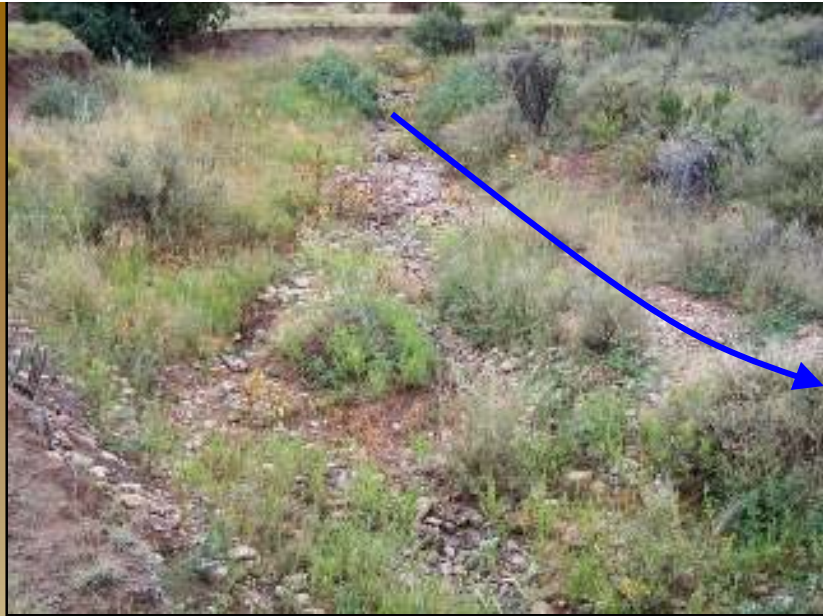
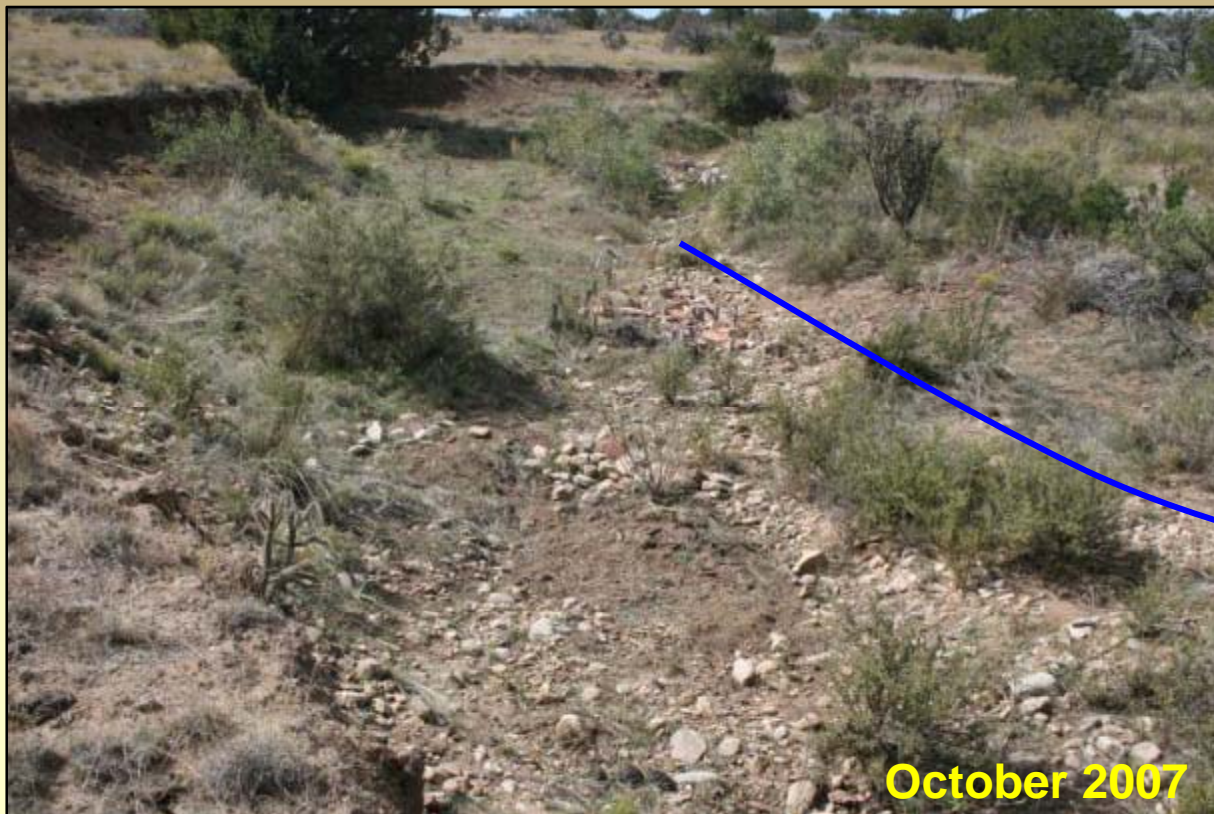
**Picket
Baffle #9**

Downstream

Upstream

Picket
Baffle #9

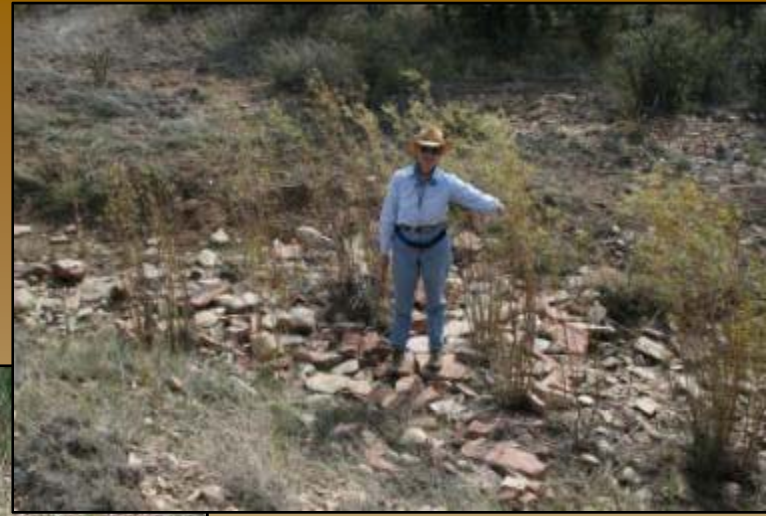
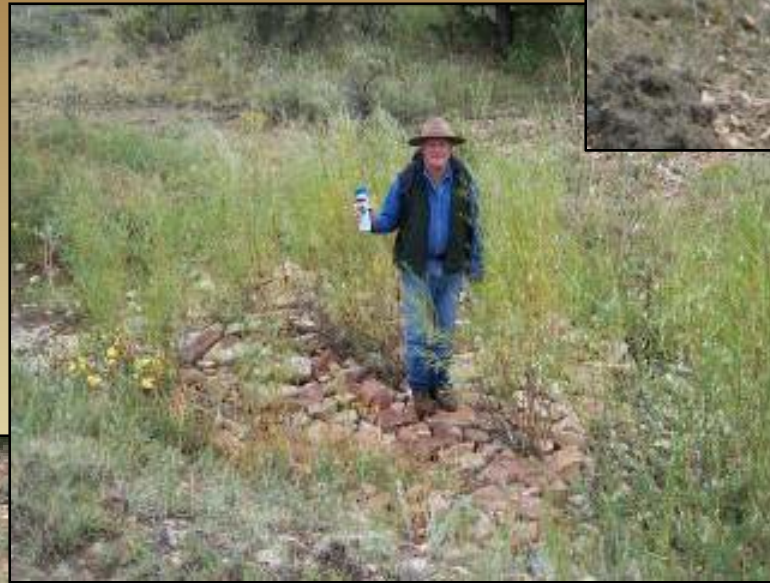
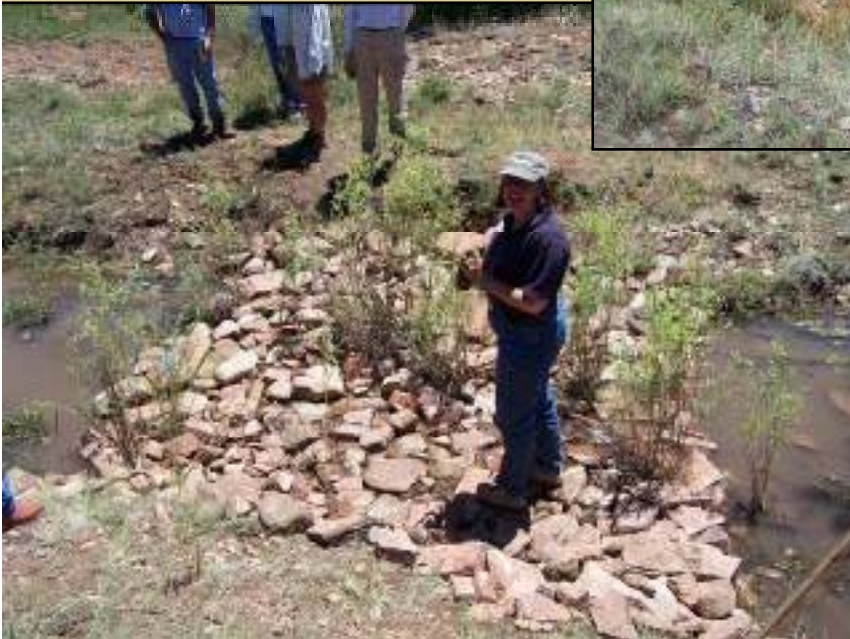
**Boulder Weir built
around existing
willows.**
